NTSB National Transportation Safety Board

Office of Marine Safety

Spud Winch Operation and Safety Features

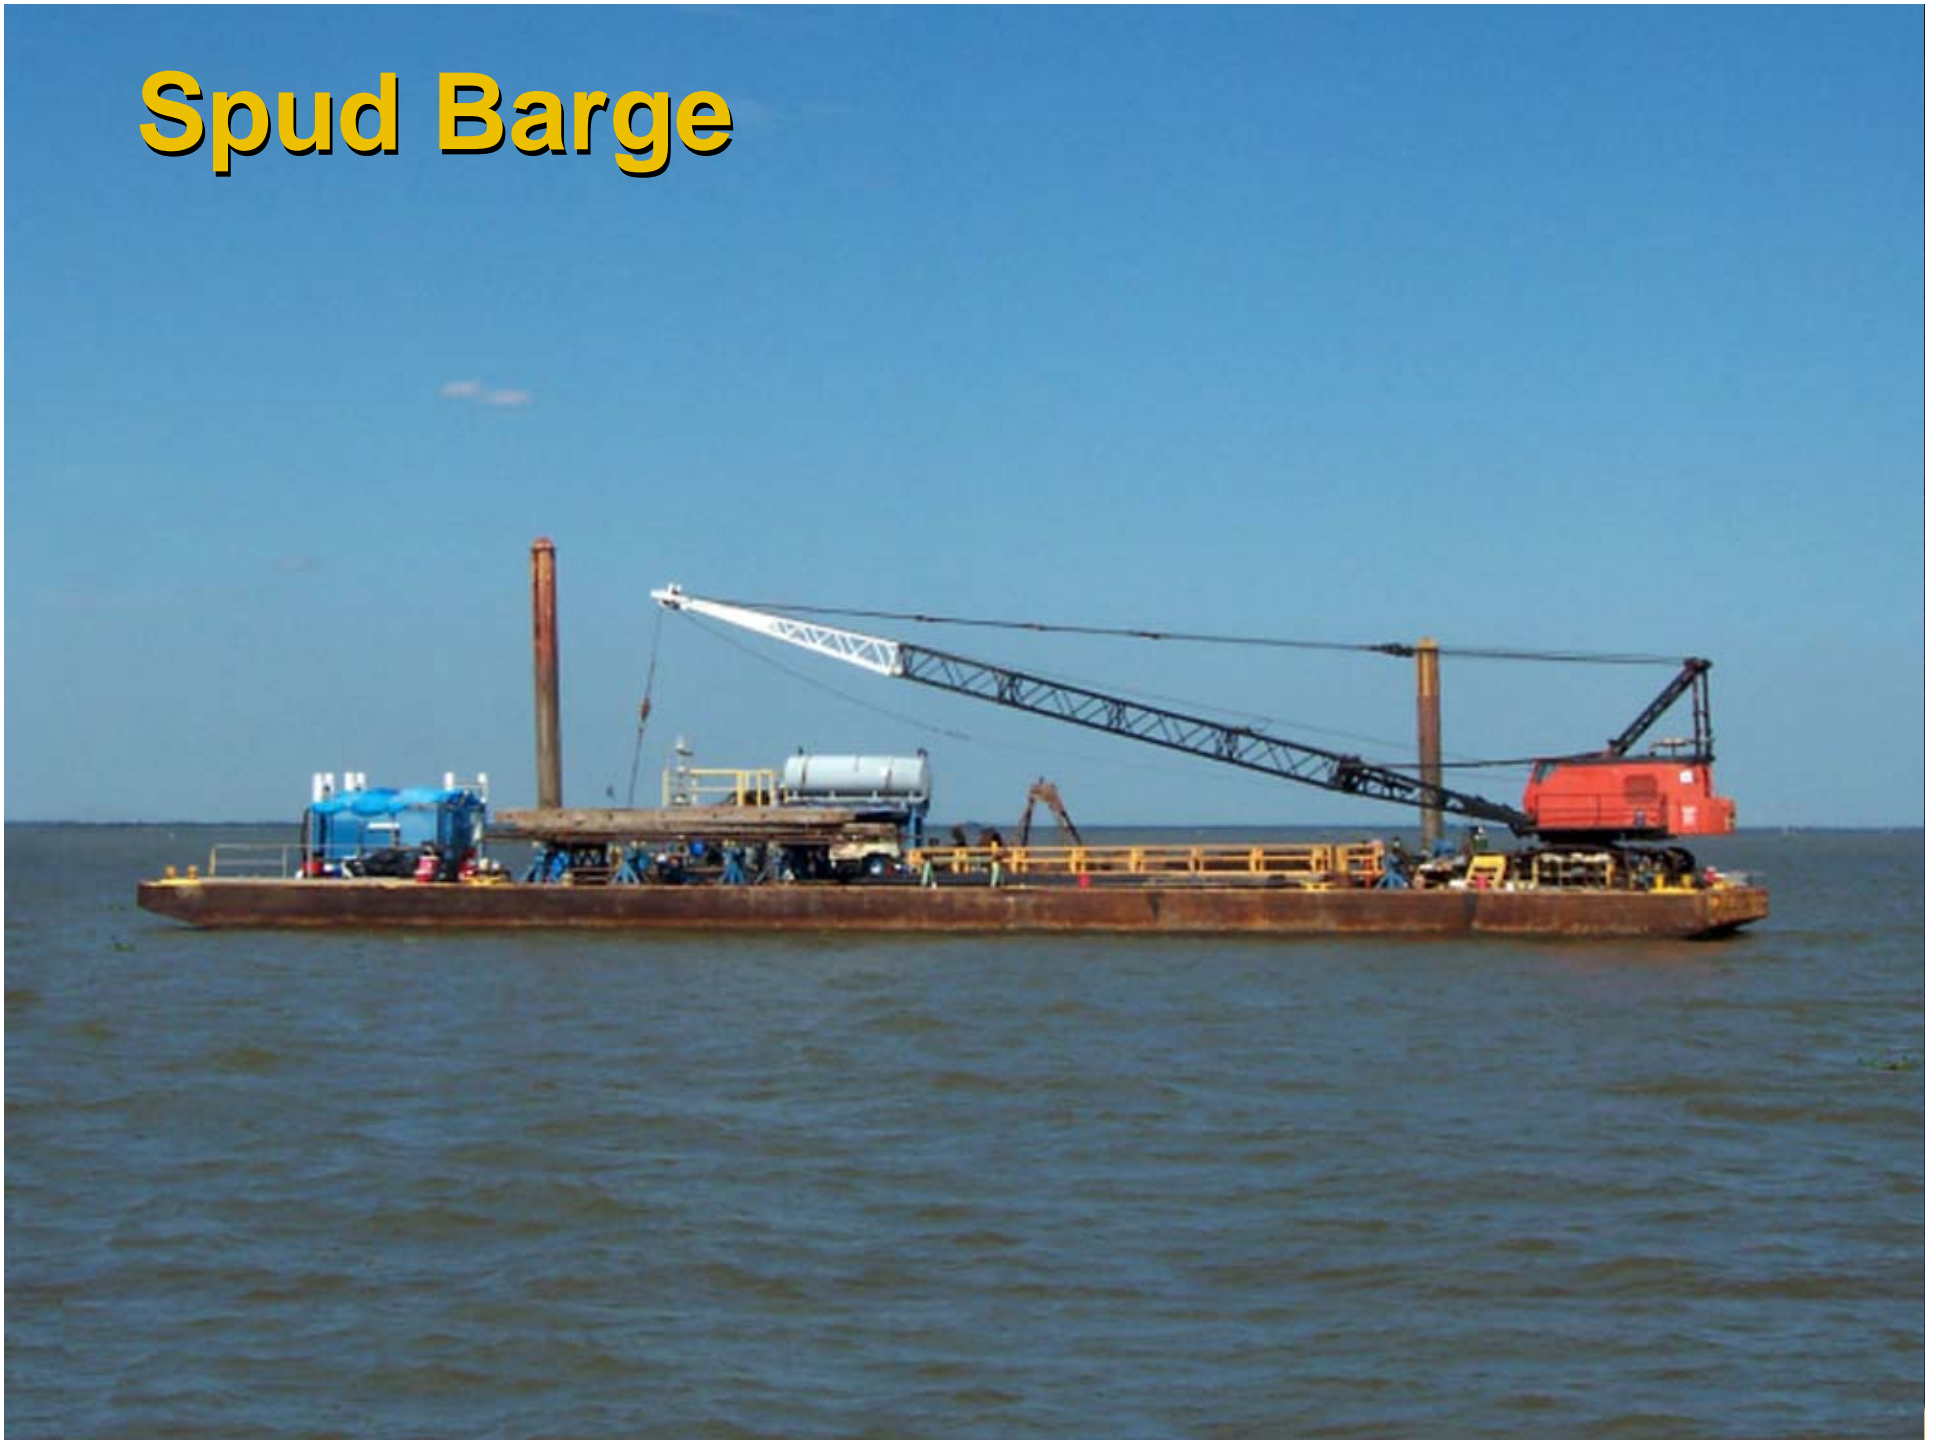
Spud Barge

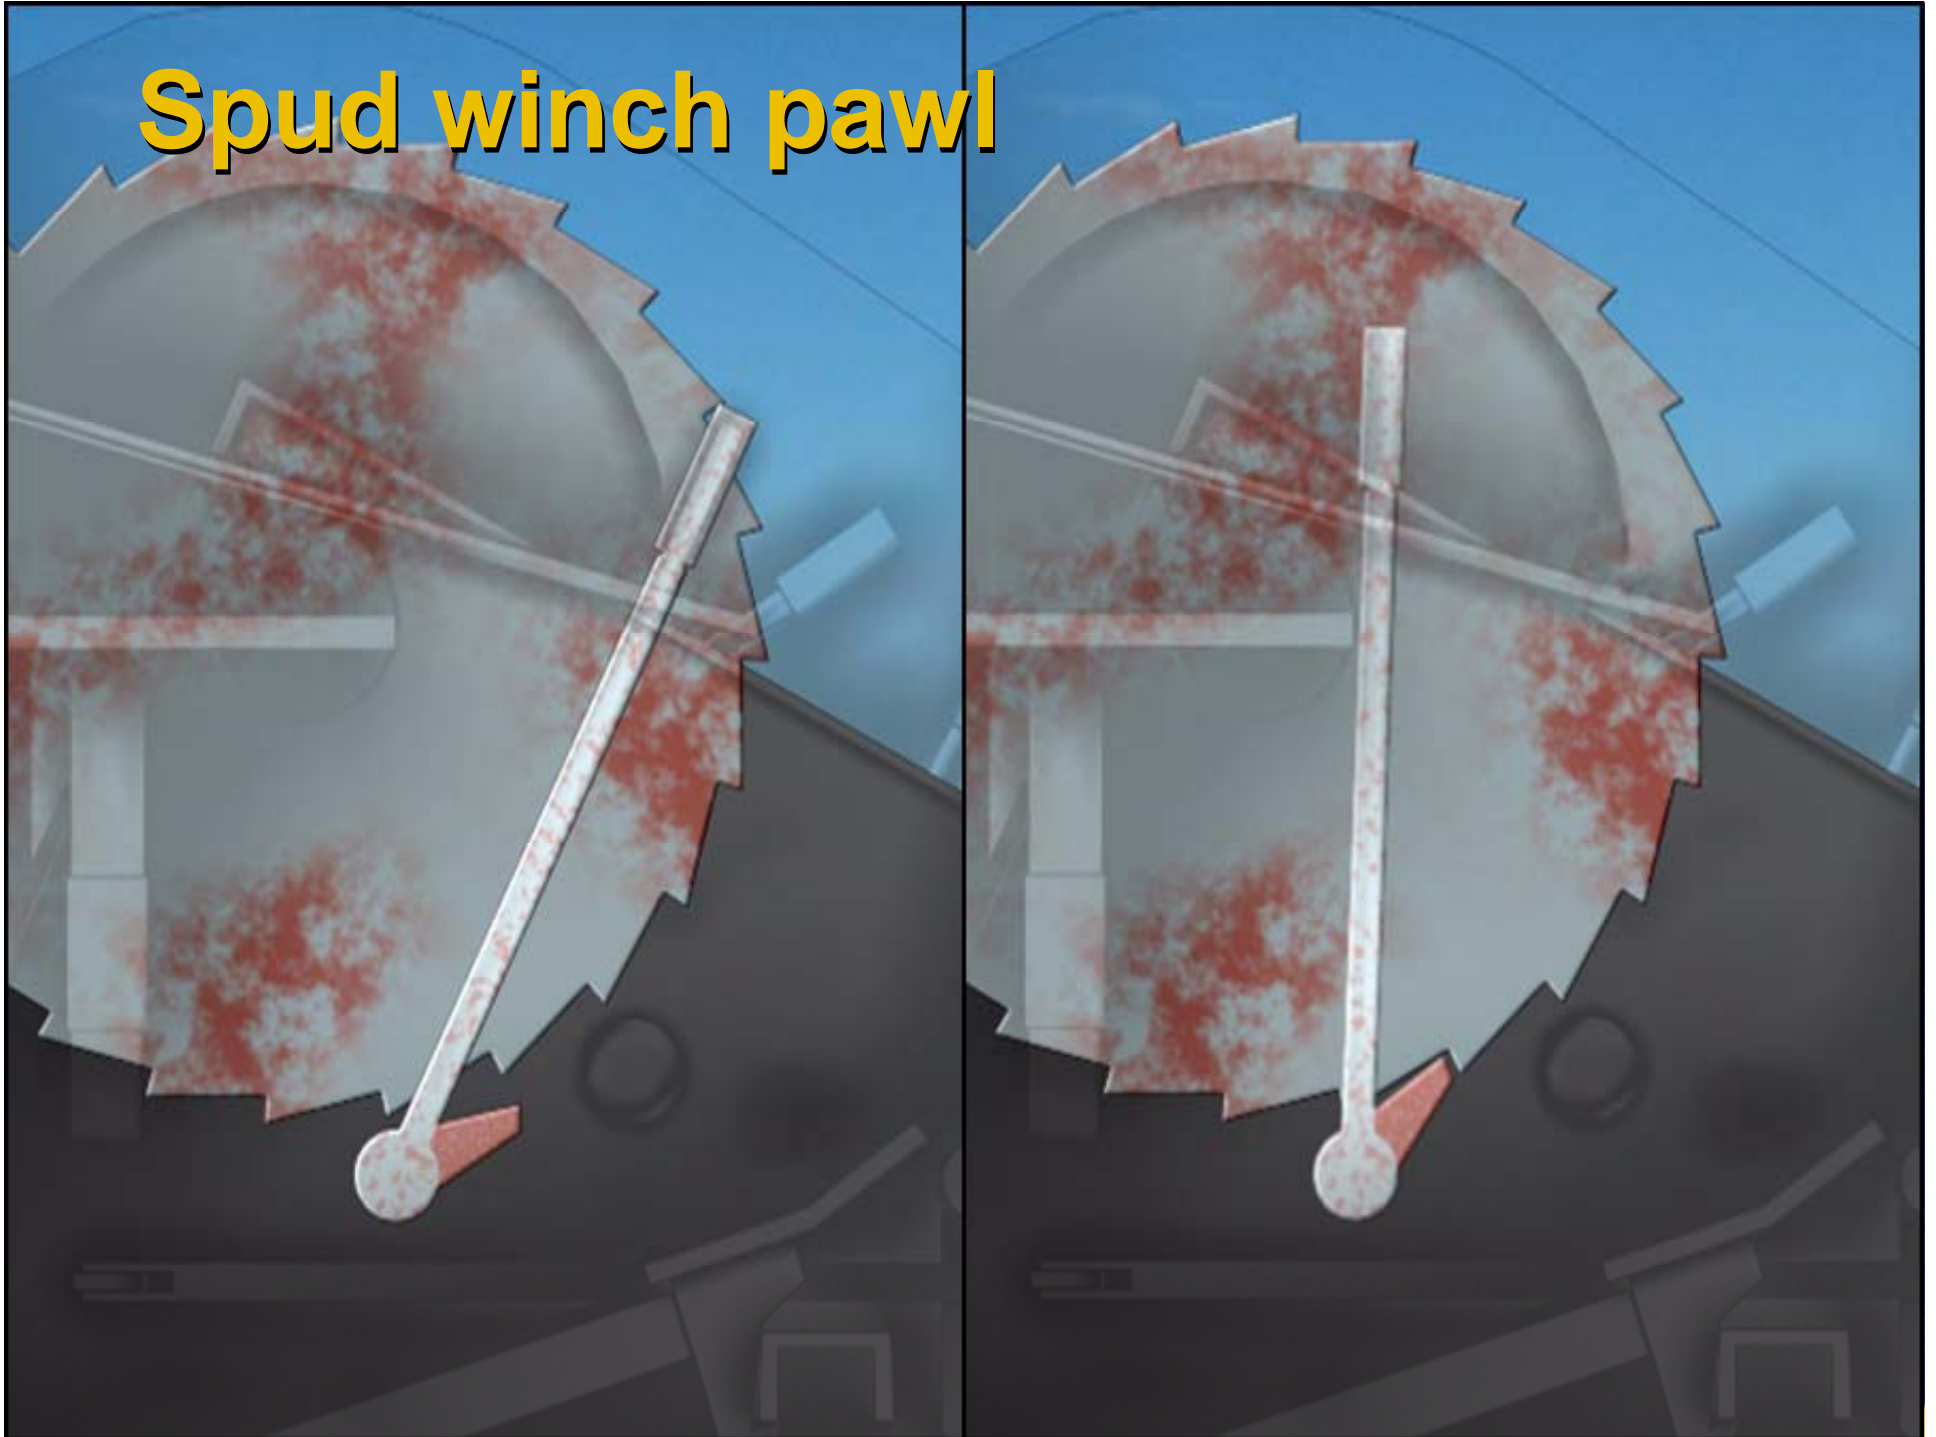
Spud winch pawl

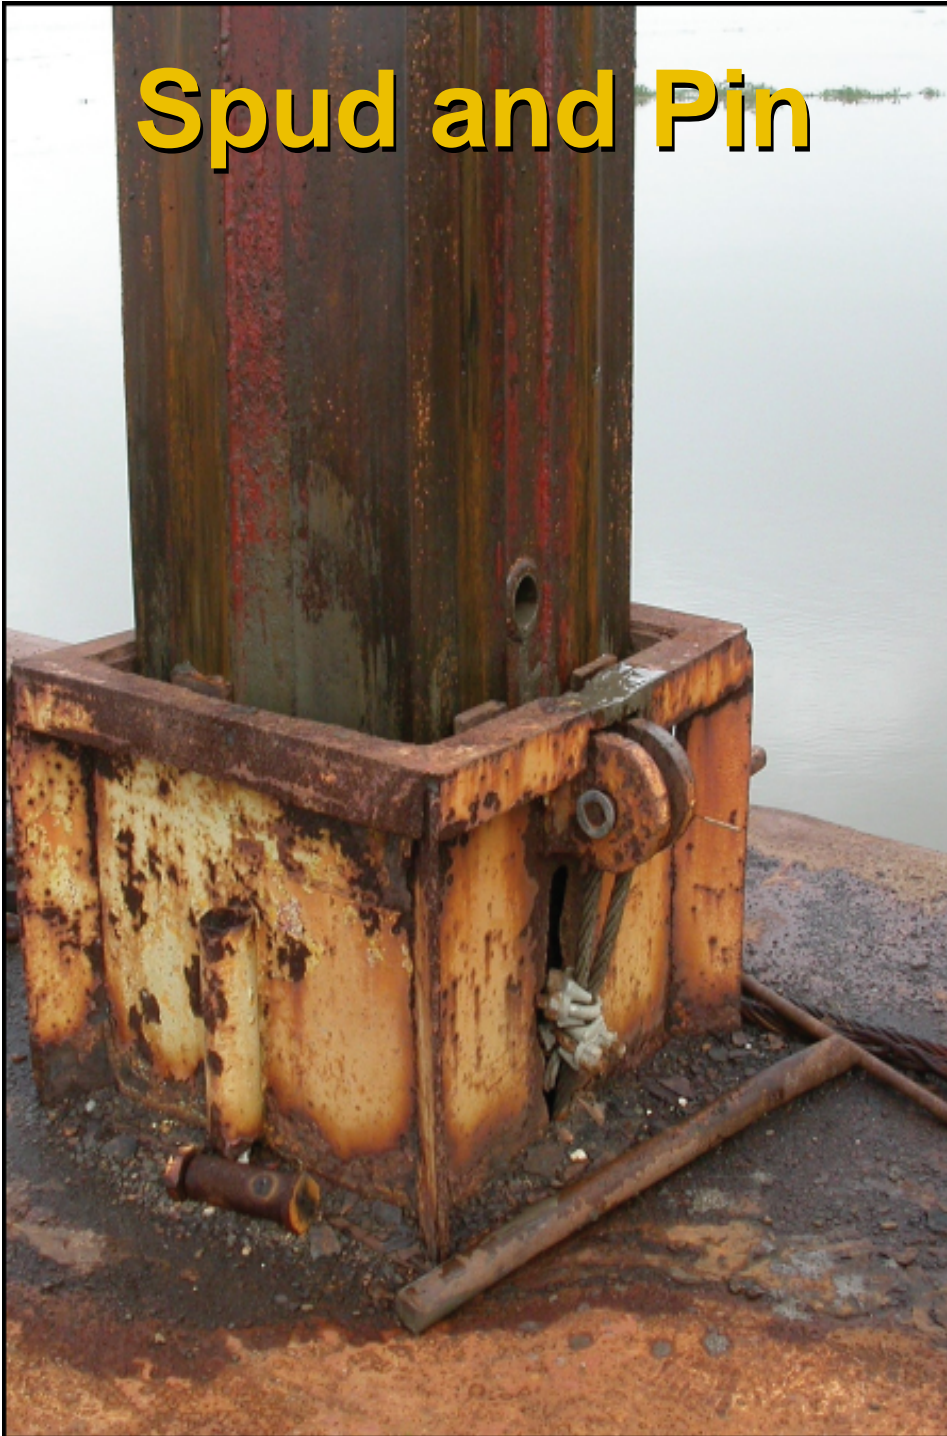
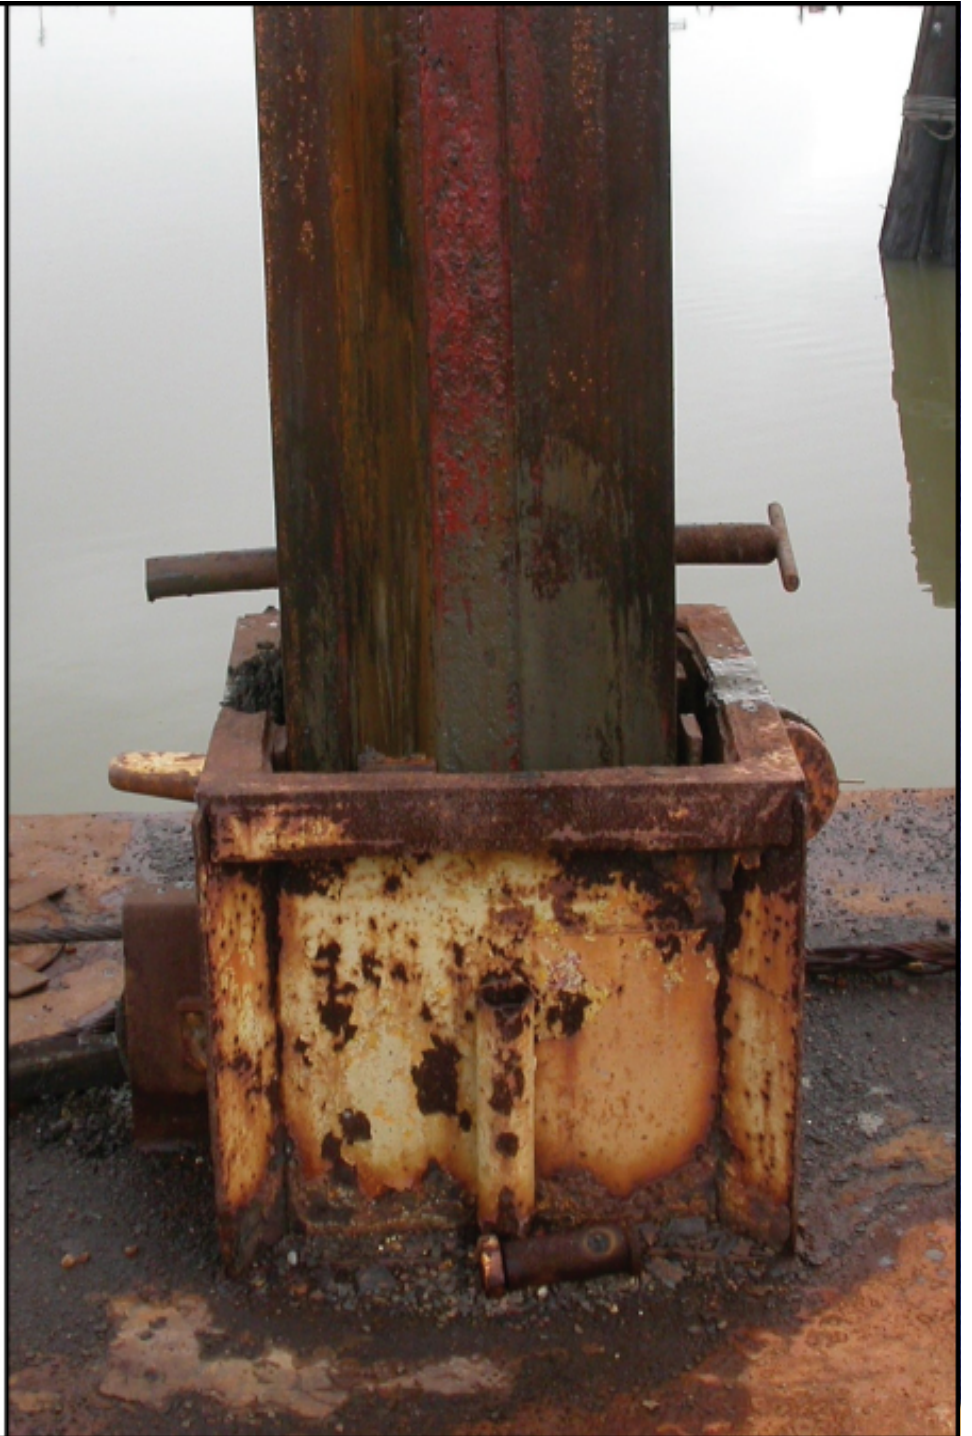
Spud and Pin

- Using spud securing pins would have prevented accident
- Companies failed to require pinning of spuds
